# Failure analysis on metal automotive production parts

## Coating defect assessment using the Axia ChemiSEM

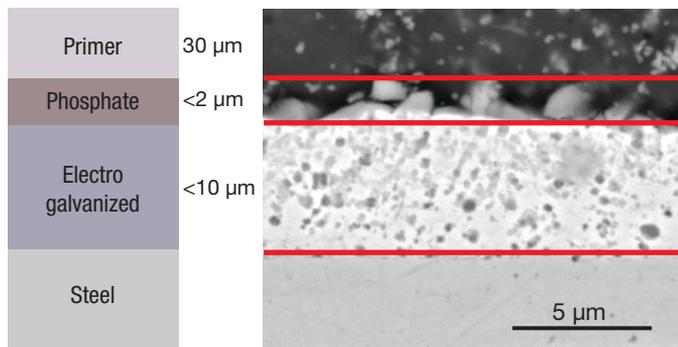
Figure 1. Schematic (left) and SEM image (right) of the different layers.

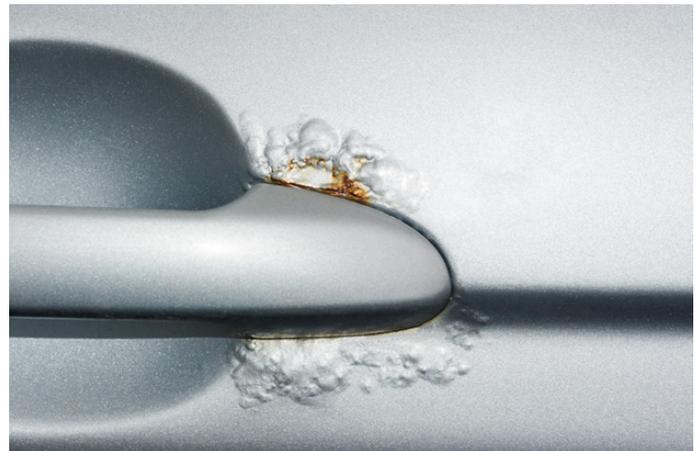
Figure 2. Defective coating on car door.

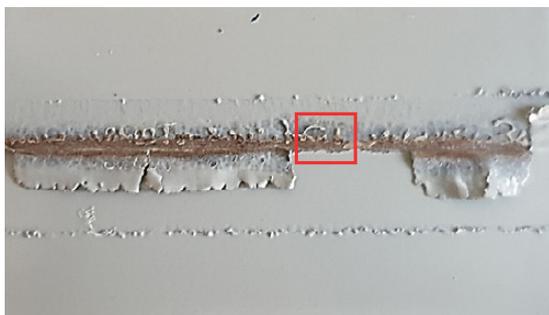
Figure 3. Sample surface.

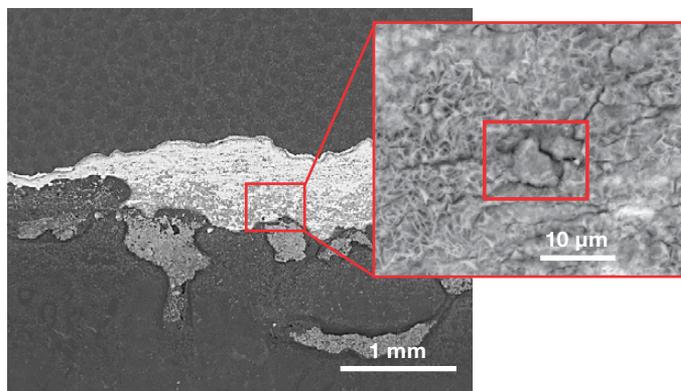
Figure 4. Low-magnification view (left) of the sample surface and a higher magnification of the area of interest (right). (Acc voltage 12 keV, beam current 0.85 nA).

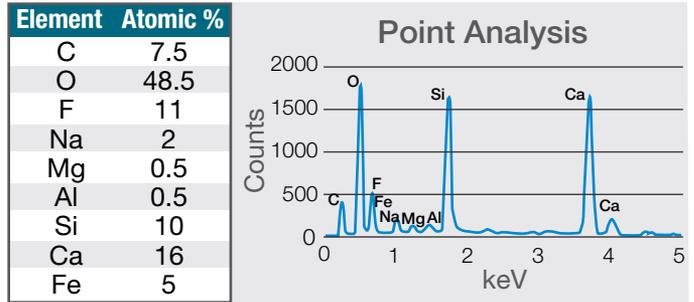
Figure 7. Quantification (left) and spectrum (right) of a 30-second area analysis acquired on the defect (Acc voltage 15 keV, beam current 0.44 nA).

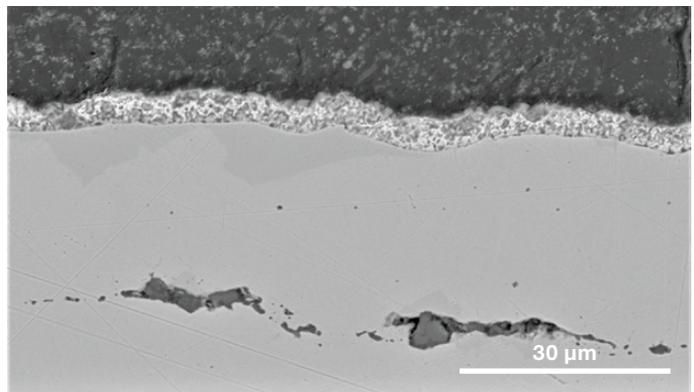
Figure 8. Cross section of the steel showing the coatings involved and the presence of sub-surface inclusions. (Acc voltage 15 keV, beam current 0.44 nA).
