Bend failure mechanism of high-strength steel

Efficient and effective root cause analysis using the Axia ChemiSEM

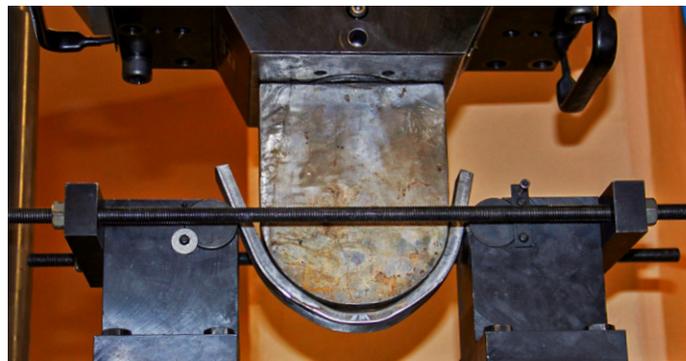
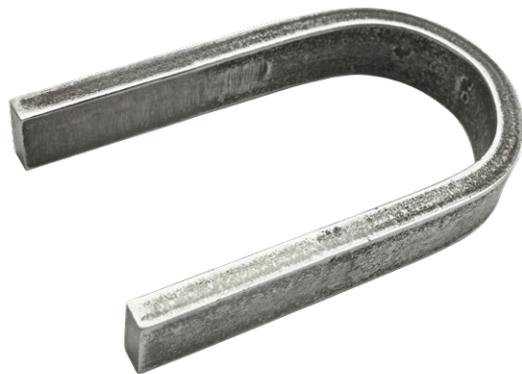
Figure 1. Bend test (top) and tested piece (bottom).

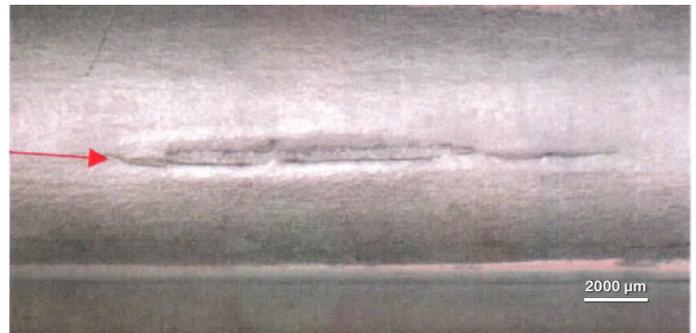
Figure 2. Image of a failed bend test.

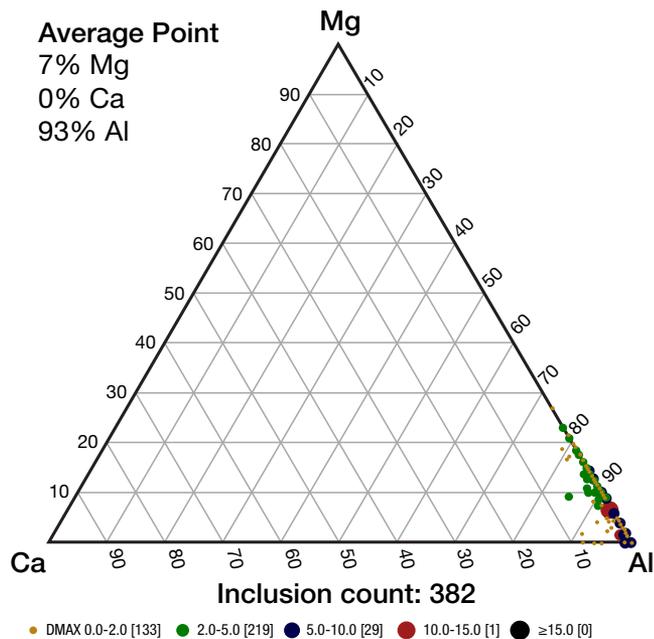
Figure 3. Base inclusion analysis was collected on this sample by the Phenom ParticleX Steel Desktop SEM.

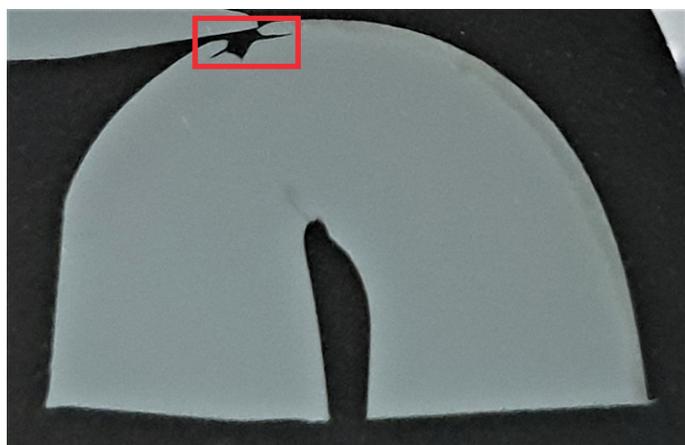
Figure 4. Cross section of a bend tested steel. The crack, propagated on the outer radius, is highlighted in red.

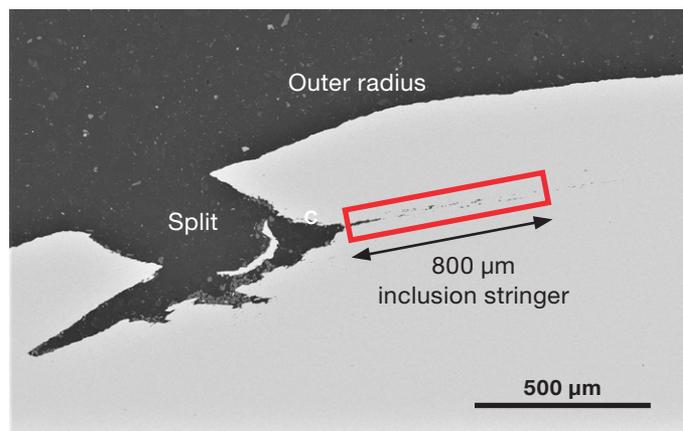
Figure 5. Backscattered electron image of the split. Highlighted area is the inclusion stringer that started at the base of the split (Acc voltage 15 keV, beam current 0.22 nA).

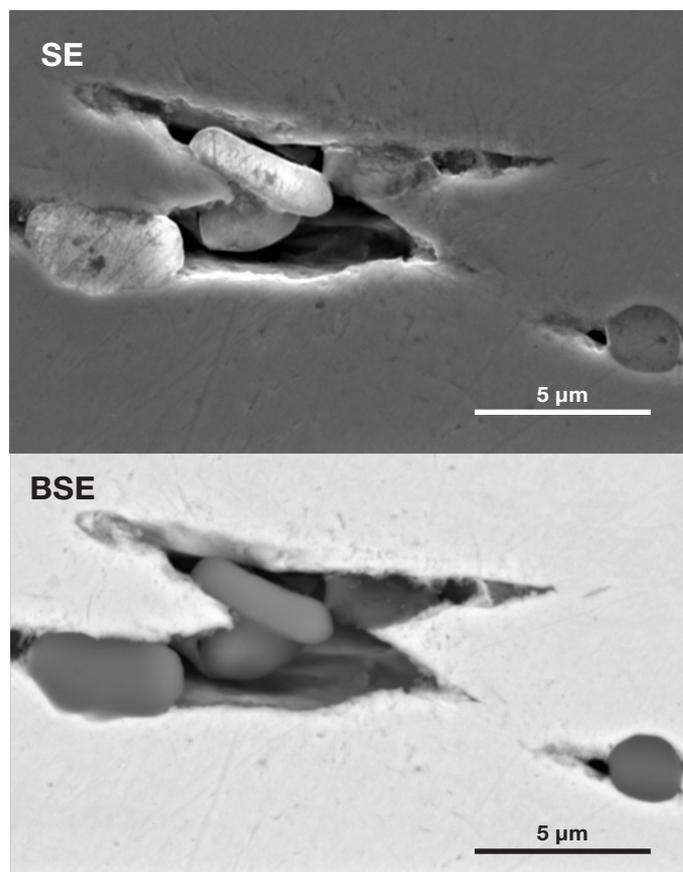
Figure 6. Higher magnification view of the inclusions in the stringer (Acc voltage 15 keV, beam current 0.22 nA, acquisition time 60 s).

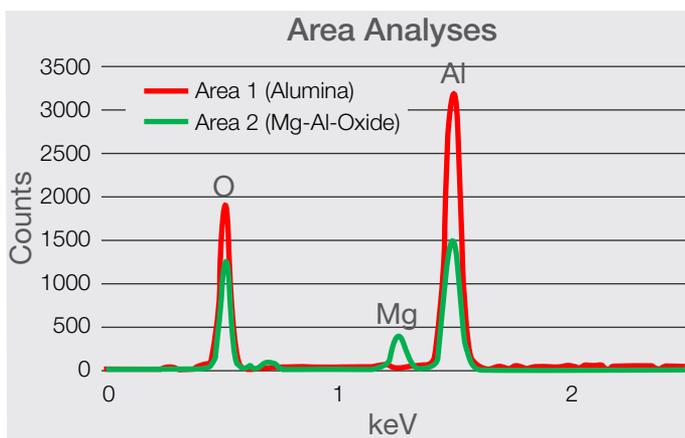
Figure 8. Spectra comparison between the two types of inclusion, showing a clear presence of magnesium ($K\alpha$ at 1.253 keV).

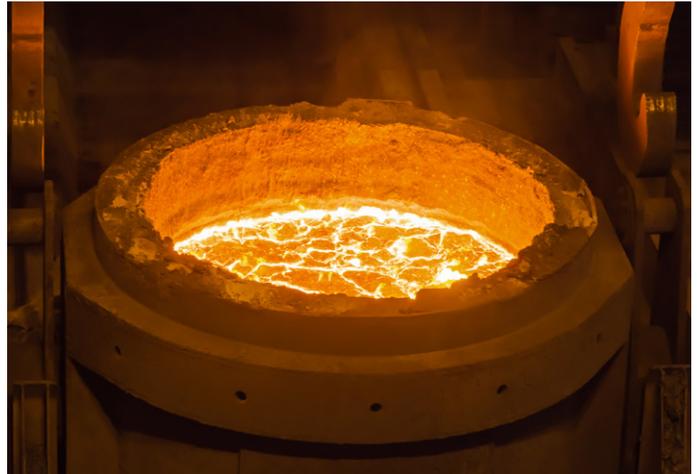
Steel refining is performed in a ladle where deoxidation, desulfurization and inclusion flotation may occur.
