Adhesion Failure Analysis

Author Tim Nunney, Thermo Fisher Scientific, East Grinstead, West Sussex, UK

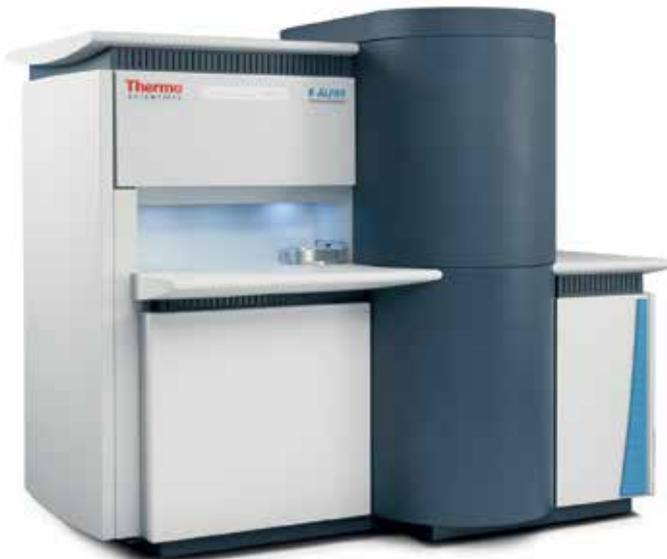
Thermo Scientific K-Alpha XPS
